**Focused Remedial  
Investigation/Feasibility Study  
Workplan**

**Richardson Flat Tailing Site  
Summit County, Utah**

**FOCUSED REMEDIAL  
INVESTIGATION/ FEASIBILITY STUDY  
WORK PLAN**

**RICHARDSON FLAT TAILINGS SITE  
SUMMIT COUNTY, UTAH**

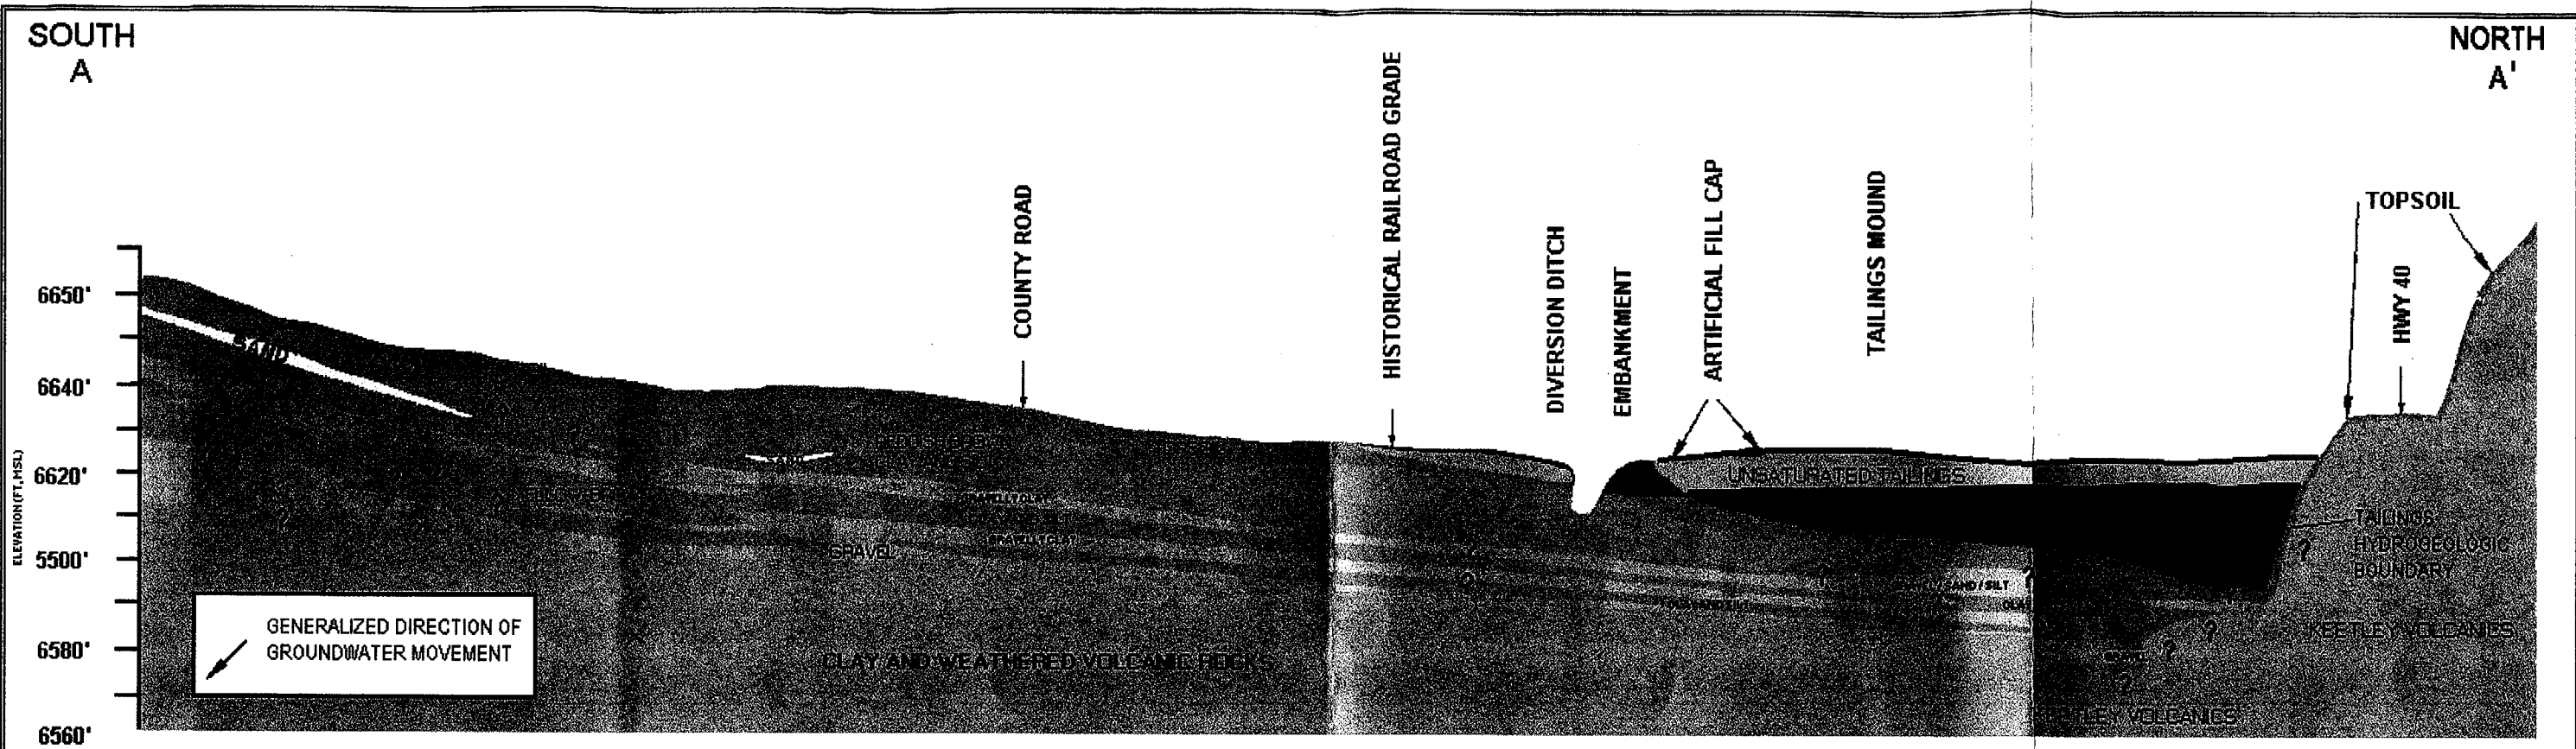
**NORTH-SOUTH CONCEPTUAL SITE MODEL CROSS SECTION**

Based on previous and current environmental studies and existing Site conditions, United Park has developed a conceptual model of the Site. The Conceptual Site Model will be used to evaluate the need for further remedial measures to support final Site closure. This model is described below and graphically portrayed in Figure 4.0.

This second potential contaminant migration pathway is inconsistent with existing, natural Site conditions. Low-permeability, native clay soil is continuous beneath the impoundment, as illustrated in Figure 4.0. Mineralogical data on the underlying soils indicate that the clay layer is comprised of a mixed clay mineral (i.e., mixed mica and illite or smectite). Based on recent studies by Weston, United Park believes that existing data establishes that it is unlikely that leached metals would migrate through the significant clay soil layer and into the underlying shallow aquifer because of the low permeability of the soil layers underlying the tailings. The tailings are derived from mineralized bodies that are hosted in carbonate or carbonate-rich rocks. These materials have a high buffering ability to counter any acid that might form as the result of sulfide degradation. Finally, there are no drinking water wells completed in the shallow or deep aquifers on or near the Site.

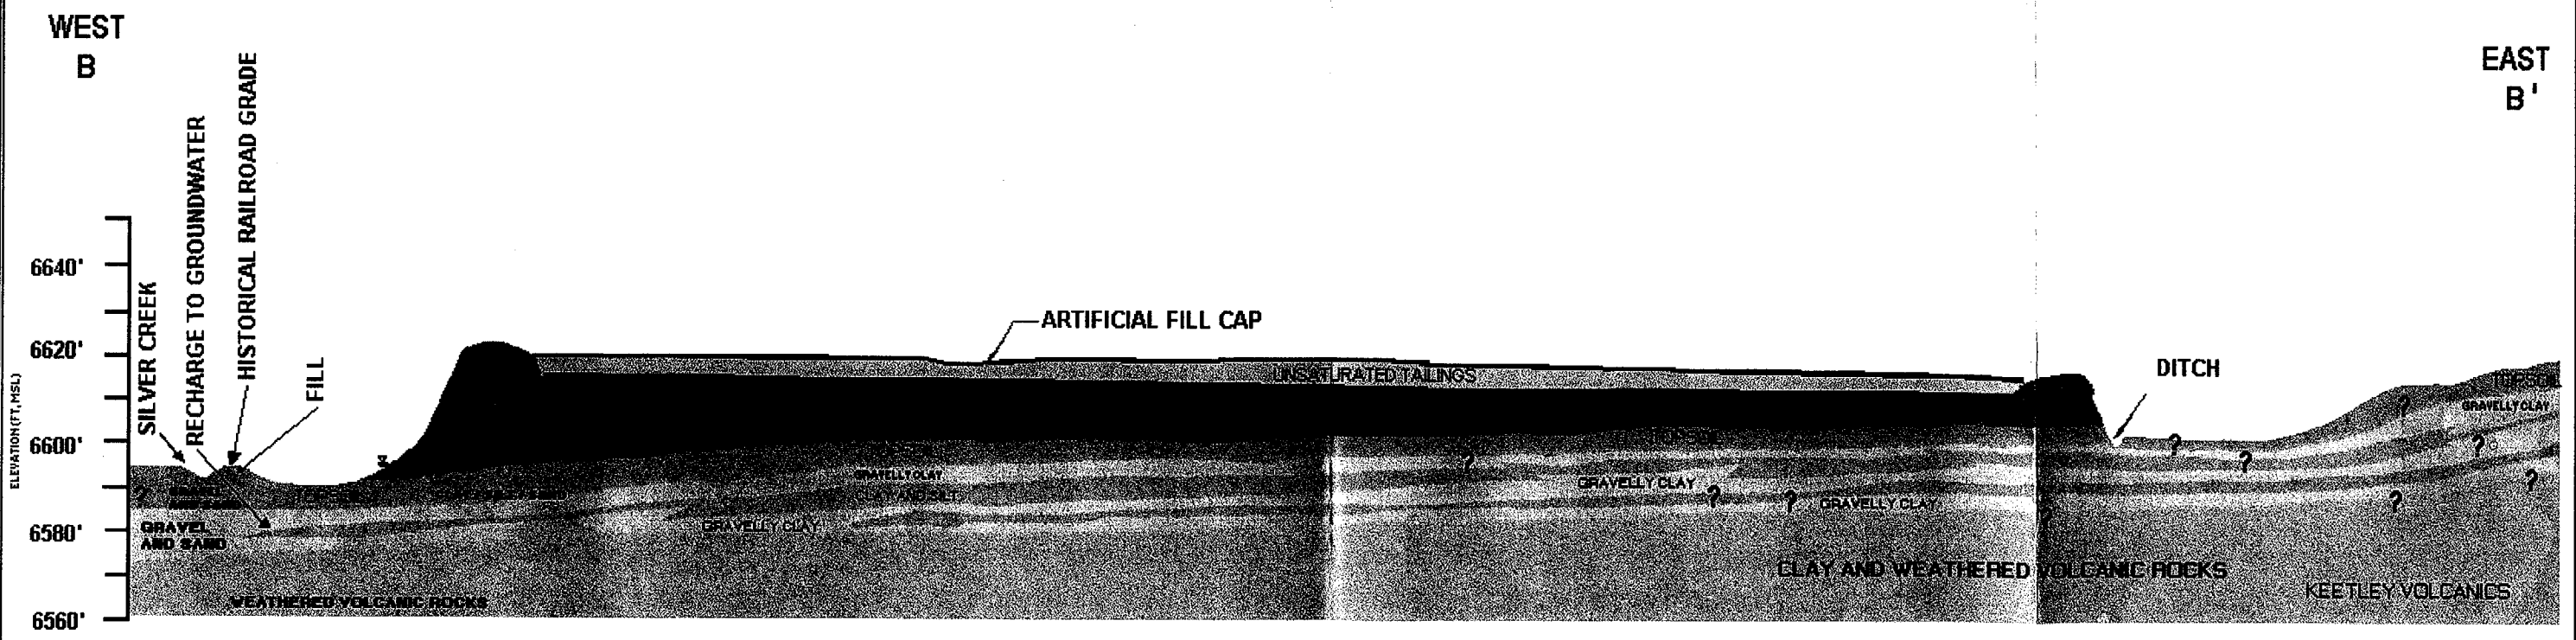
**EAST-WEST CONCEPTUAL SITE MODEL CROSS SECTION**

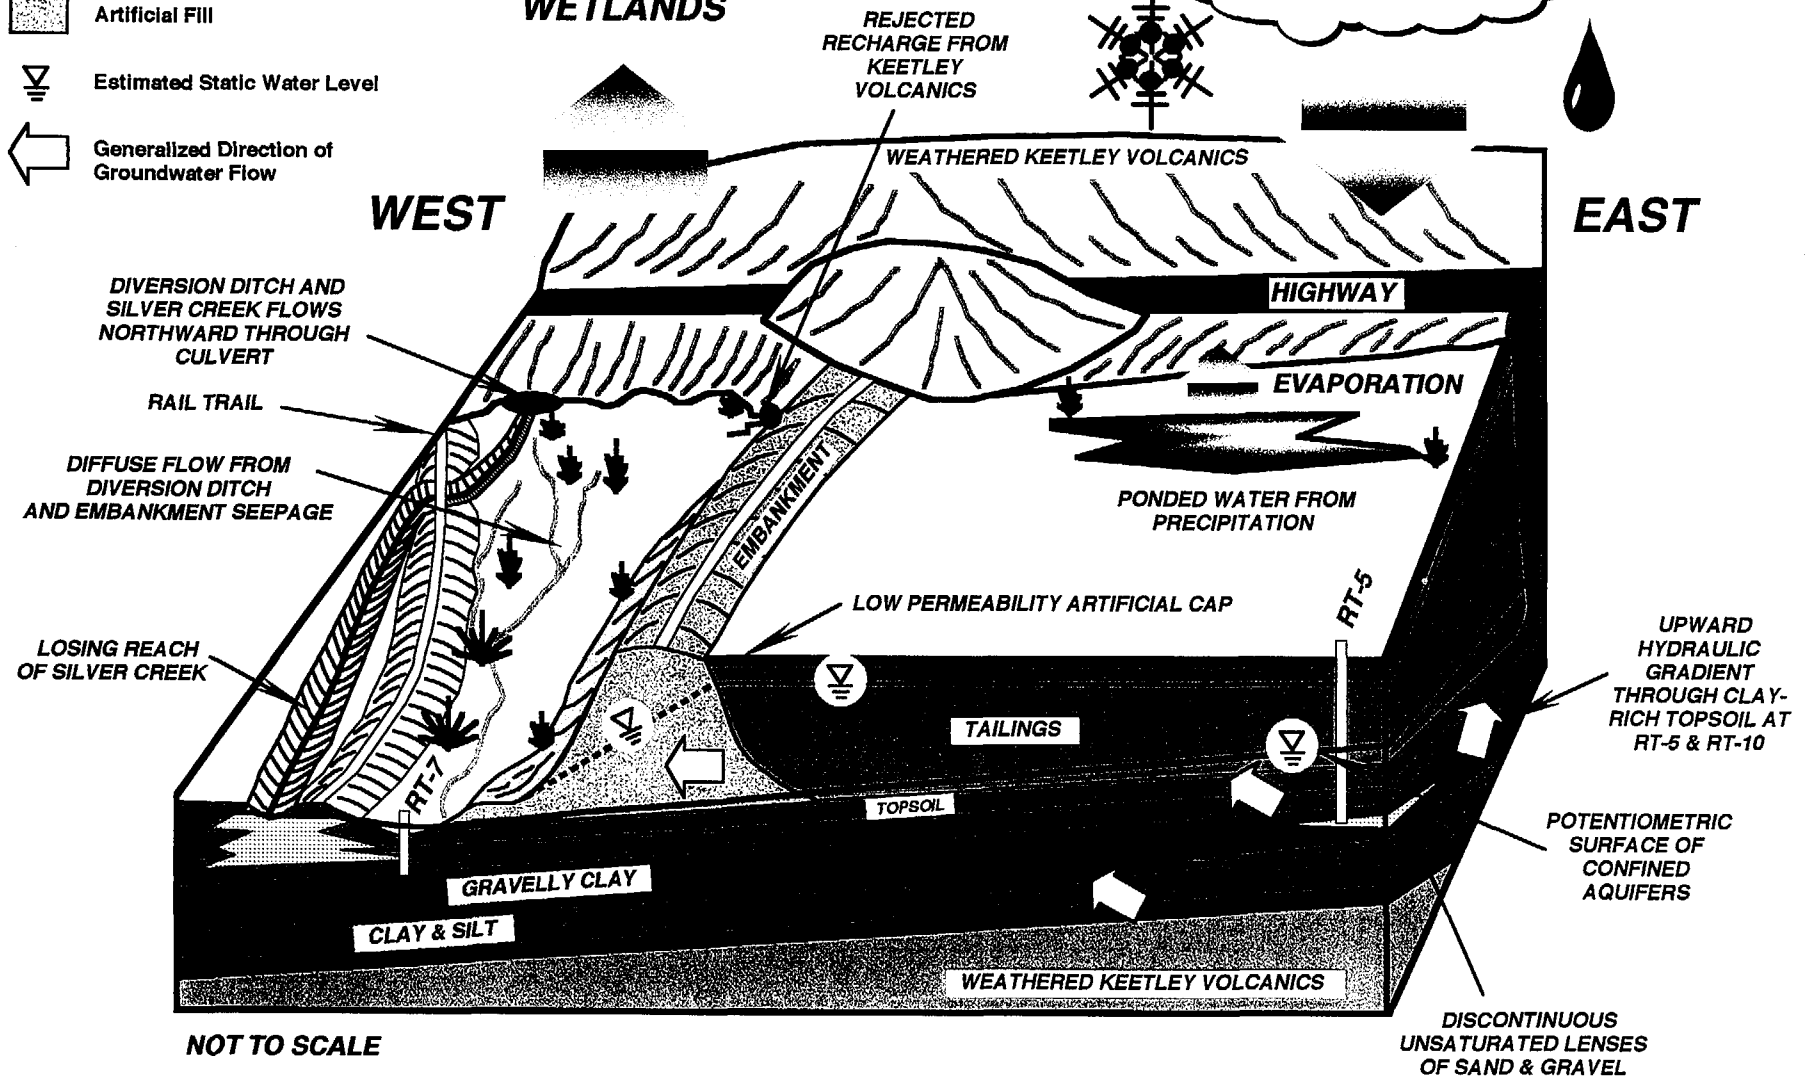
Generalized Direction of Groundwater Flow

upward in the vicinity of the tailings impoundment and directed towards the diversion ditch and Silver Creek, both serving as local hydraulic sinks. Discharge to low areas occurs along the toe of the embankment as water stored in the impounded area seeps through the embankment as originally designed as an engineered structure. Seepage also apparently occurs along the northern extent of the embankment which may reflect rejected recharge from the weathered volcanic rocks or water seepage from the impounded tailings. As indicated in the following section, the bulk of the seepage across the tailings embankment as well as the diffuse flow from the diversion ditch completes the hydrologic cycle by evaporation or evapotranspiration through consumptive use by the wetlands located in the low area between the tailings embankment and Silver Creek.

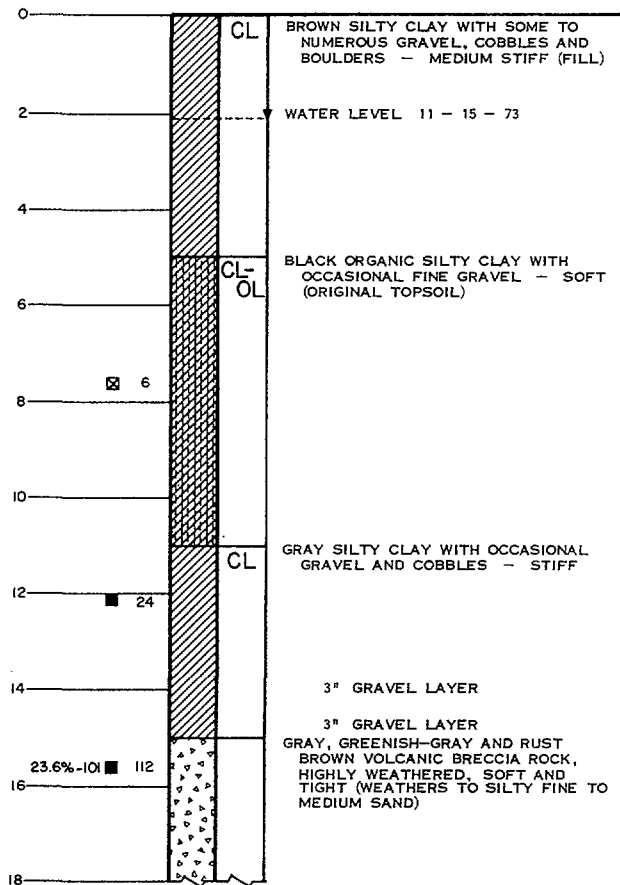
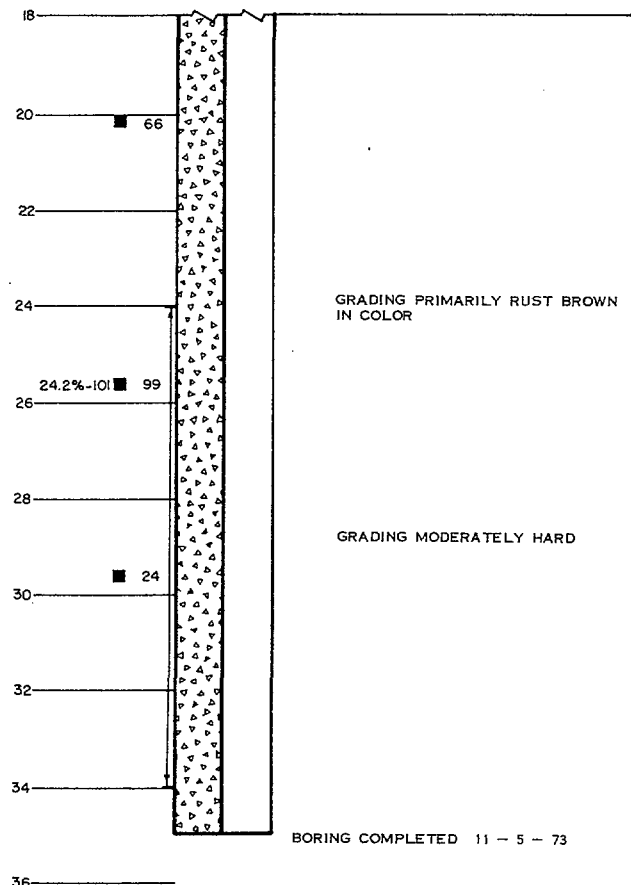
# MONITOR WELL 1

ELEVATION 6596.9 FEET

- A - B C
- A FIELD MOISTURE EXPRESSED AS A PERCENTAGE OF THE DRY WEIGHT OF SOIL
- B DRY DENSITY EXPRESSED IN LBS. PER CUBIC FOOT
- C BLOWS PER FOOT OF PENETRATION USING A 140 LB. HAMMER DROPPING 30 INCHES
- DEPTH AT WHICH UNDISTURBED SAMPLE WAS EXTRACTED
- ☒ DEPTH AT WHICH DISTURBED SAMPLE WAS EXTRACTED
- ⌈ SCREENED AND GRAVEL PACKED

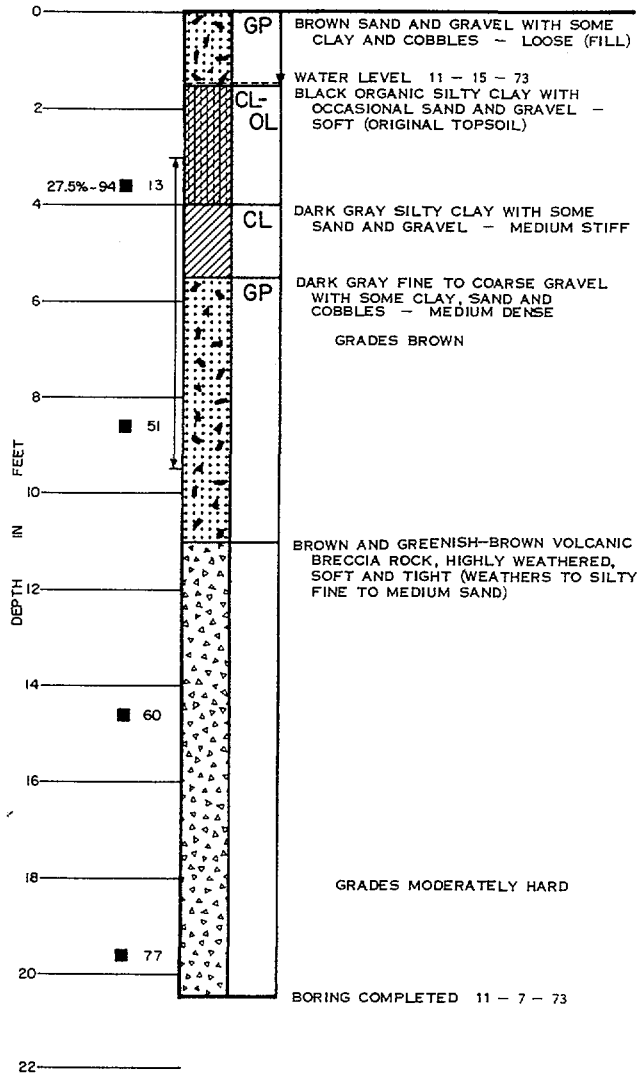
## MONITOR WELL 2

ELEVATION 6596.4 FEET

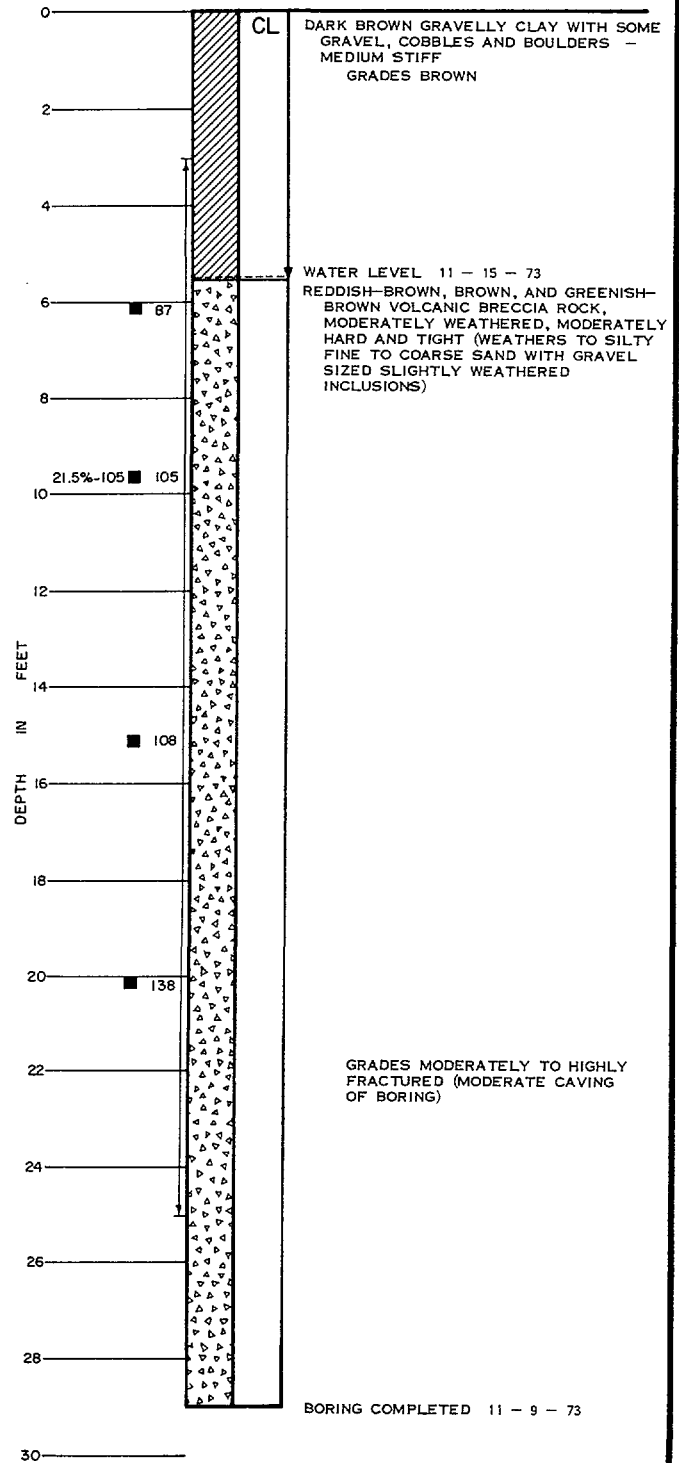
## MONITOR WELL 3

ELEVATION 6604.1 FEET
